DAMAGE ANALYSIS AS A STEP TOWARDS COMPATIBLE REPAIR MORTARS

Rob P.J. van Hees¹, Luigia Binda², Ioanna Papayianni³, Eleni Toumbakari⁴

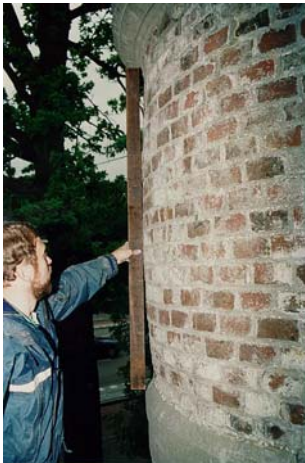
Fig. 3.1.1 Bulging of masonry. This part of the wall was already furnished with new pointing.

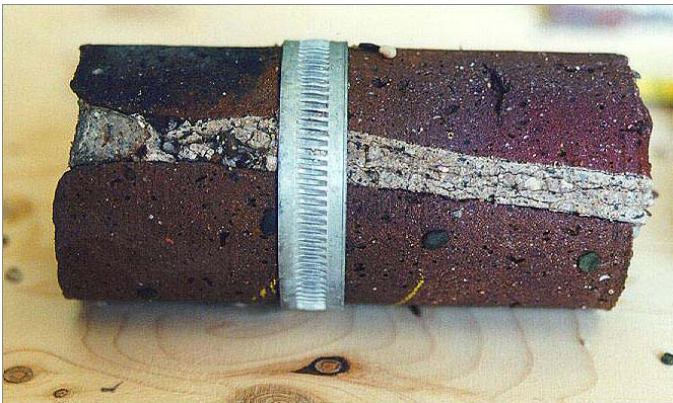
Fig. 3.1.3 Layering of the bedding mortar caused by frost test on a core of Ø 50 mm.

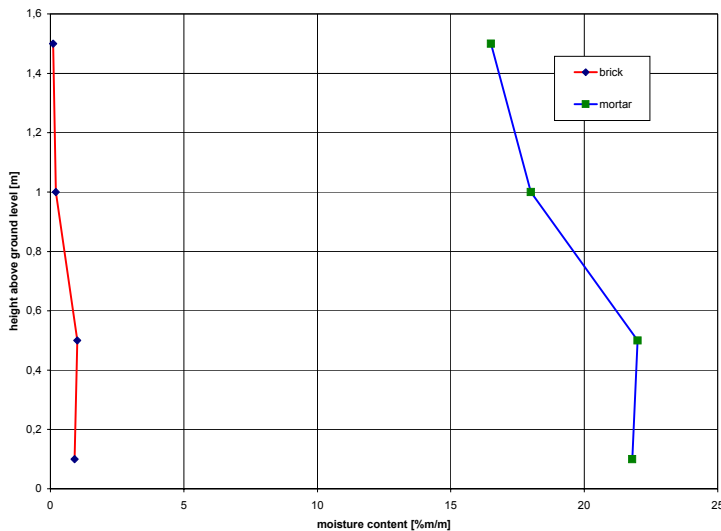
Fig. 3.1.4 Moisture distribution over the wall height for both mortar and brick.

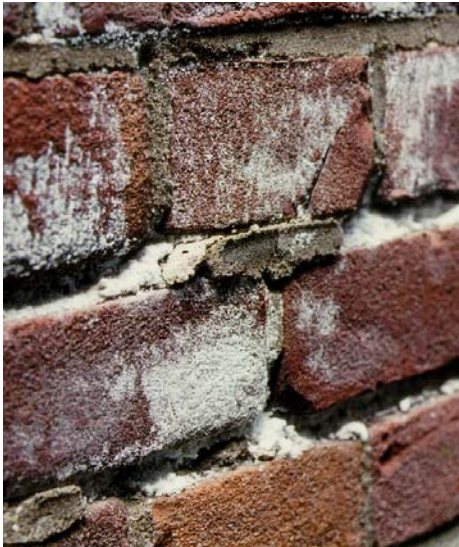
Fig. 3.2.1 As a result of salt crystallisation at the interface between bedding and pointing mortar the pointing has been forced out.

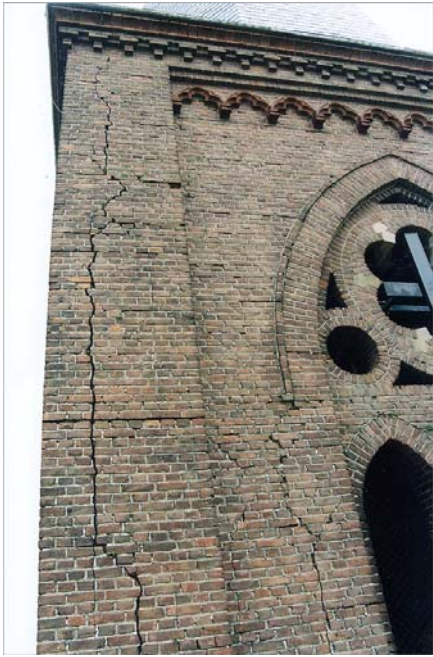
Fig.3.3.1 Wide (vertical and also horizontal) cracks, on the first sight looking like structural cracks, were found to be caused by swelling compounds in the inner part of the masonry.

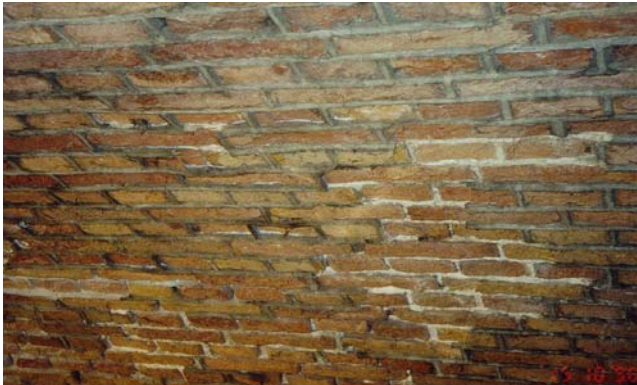
Fig. 3.3.2 Damage in the passage(way) of a historical arch bridge: spalling of brick and pointing is pushed out.

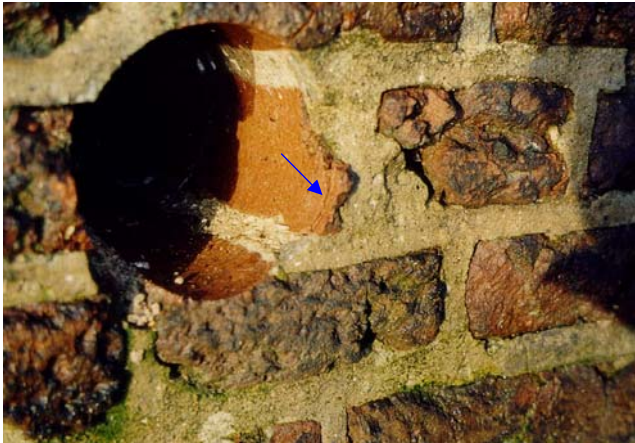
Fig. 3.3.3 Start of damage visible in the hole left by the drilled core (see arrow for location): a layer of the brick begins to detach, the bedding mortar shows loss of cohesion.

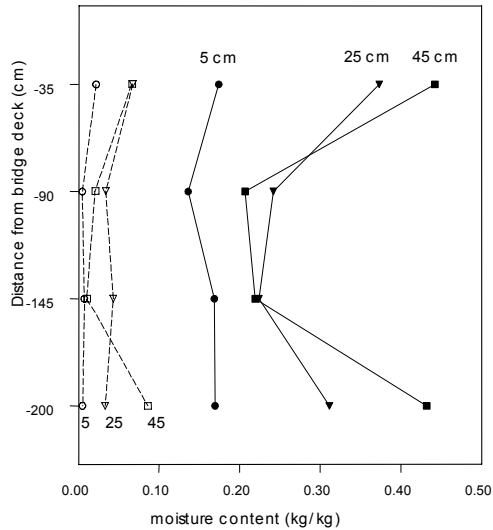
Fig. 3.3.4 The moisture content (and distribution) in one of the bridge pillars as a function of the distance from the bridge deck and as a function of drilling depth (5, 25 and 45 cm). The continuous lines indicate the moisture profile. The dotted lines represent the hygroscopic moisture content at 93% RH and give an indication of the salt profile.

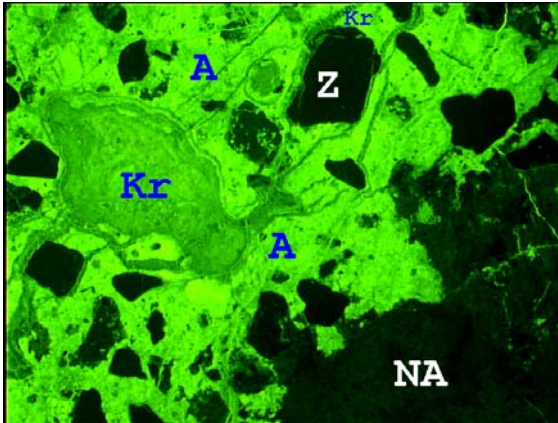
Fig. 3.3.5 PFM picture (fluorescence) of decayed mortar. The dark not decayed zone has lower porosity than the left part (lighter colour) the porosity is clearly higher; this is due to the dissolution of the binder. 'A' is used to indicate the decayed zone, 'NA' for the undecayed zone. The decay is shown by this phenomenon as well as by concentrations of structures in crystal form indicated by 'Kr'. Dimensions of the section shown are 2,7 x 1,8 mm (magnification: 50x). Location +/- 200 cm below bridge deck, depth 5 to 10 cm from the wall surface (see fig. 3.3.4).

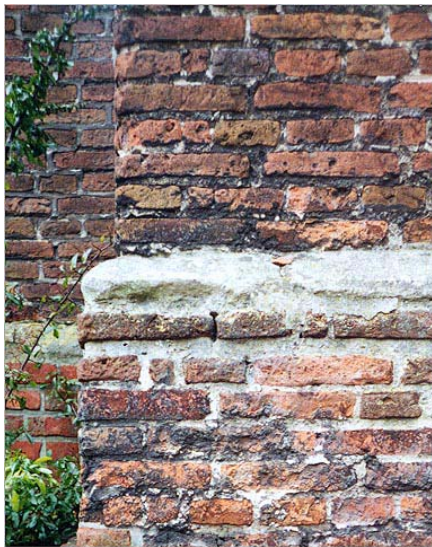
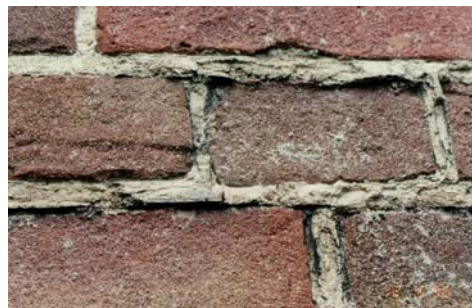
Fig. 3.4.1a b. Detail of the pointing mortar bursting.
Fig. 3.4.1b a. Partially detached black crust on mortar joints.

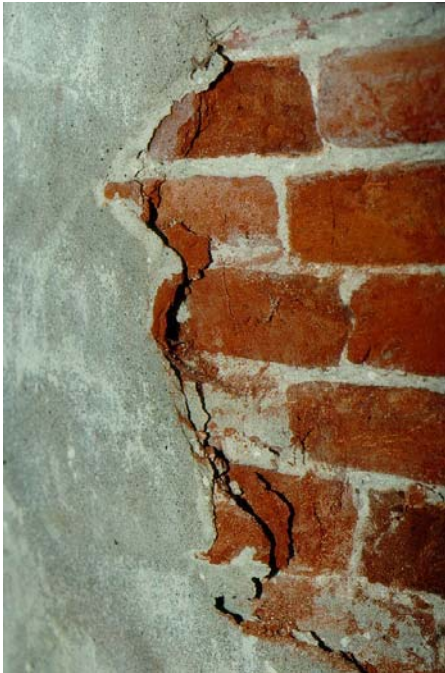
Fig. 3.5.1 Exfoliation (layering) of plaster and masonry inside the windmill.

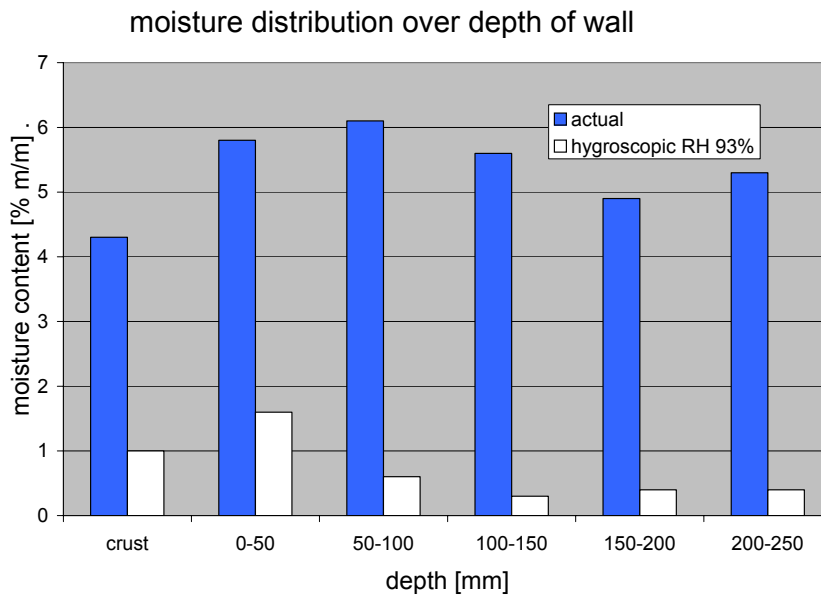
Fig. 3.5.3 Moisture distribution over the section of the wall (depth from the inner surface). Also the hygroscopic moisture content is shown.

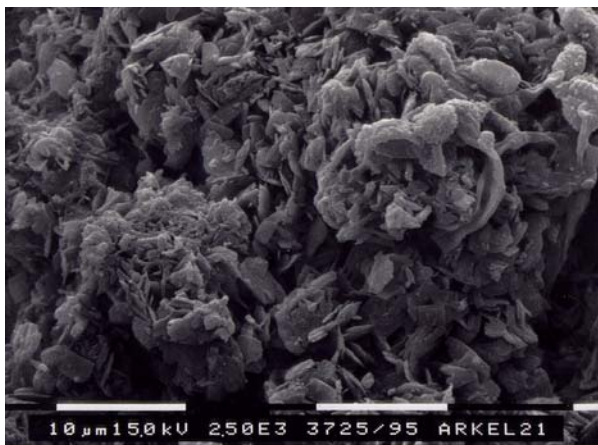
Fig. 3.5.4 SEM photo of the decayed zone of the brick showing calcium sulfate (most probably gypsum) crystals.

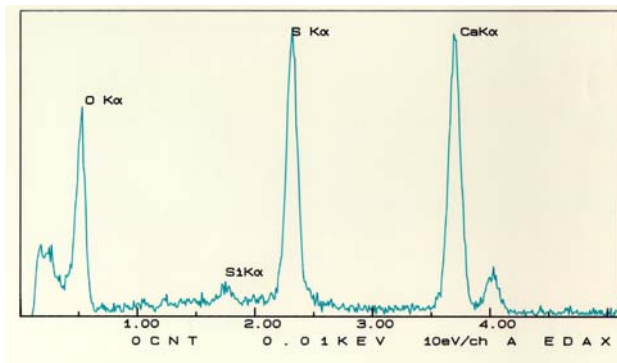
Fig. 3.5.5 EDX showing the presence of Ca, S and O: CaSO₄.

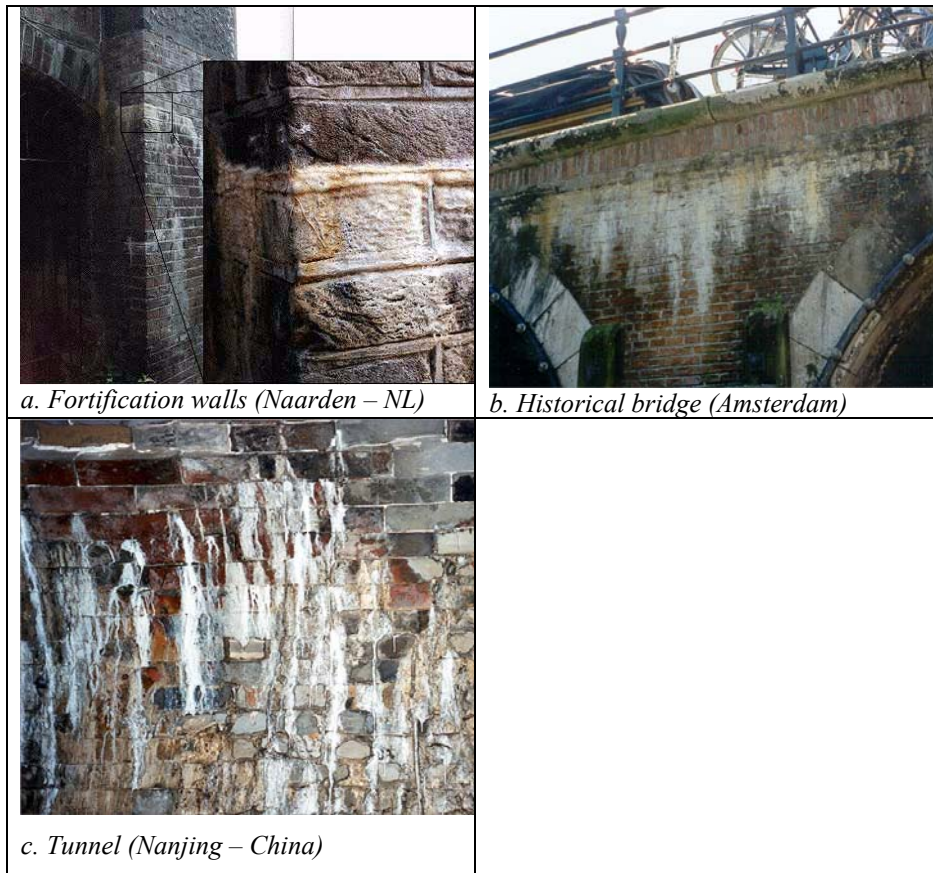
Fig. 3.6.1 Examples of encrustations. Especially in the case of the wall belonging to the fortification (a) the hard and glassy structure, which is difficult to remove, is clearly visible. Leaching may sometimes lead to the formation of stalactites as the Nanjing example (c) is showing.

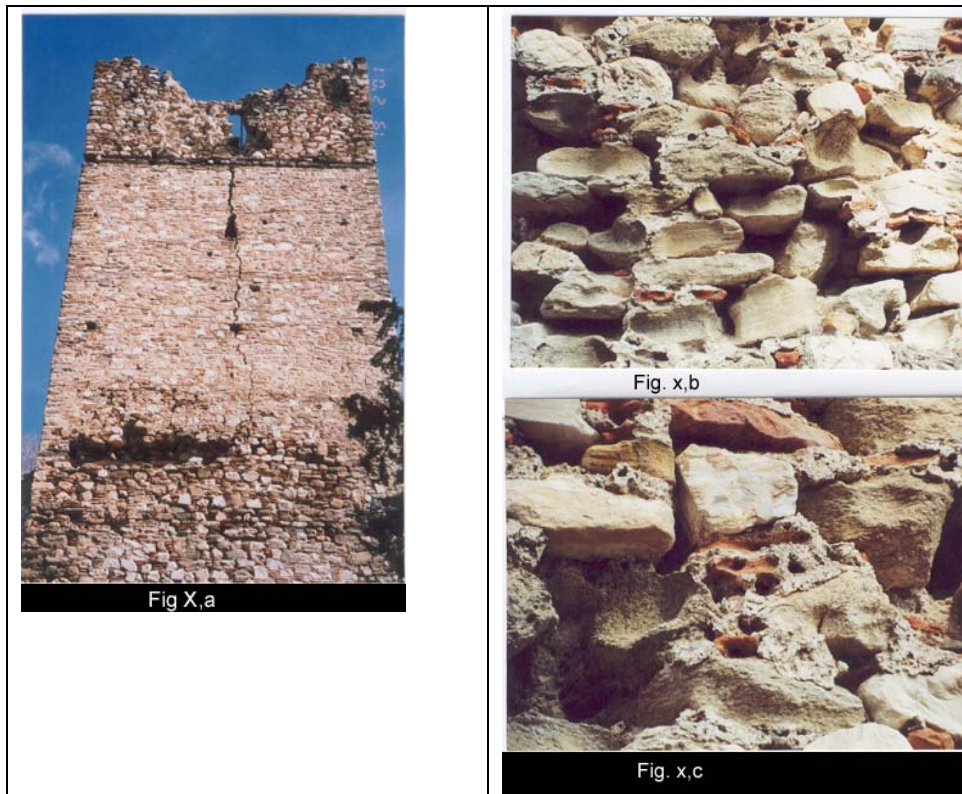
Fig. 3.7.1 a. Tower of the castle of Serbia (N. Greece, 11th century) suffering from erosion; b/c. details of the eroded lime mortar.

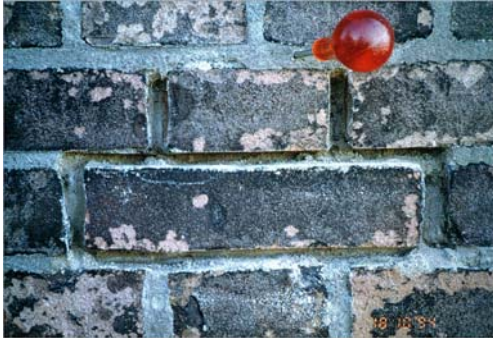
Fig. 3.7.3 Weak, decayed trass lime re-pointing.

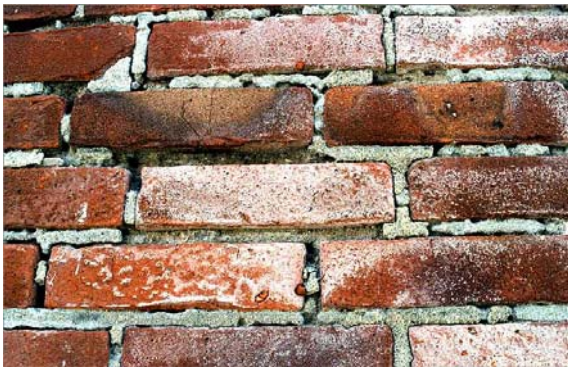
Fig. 3.8.1 Decay of pointing mortar (voids) due to sea salt action. Notice that the decay starts at the interface between brick and mortar.

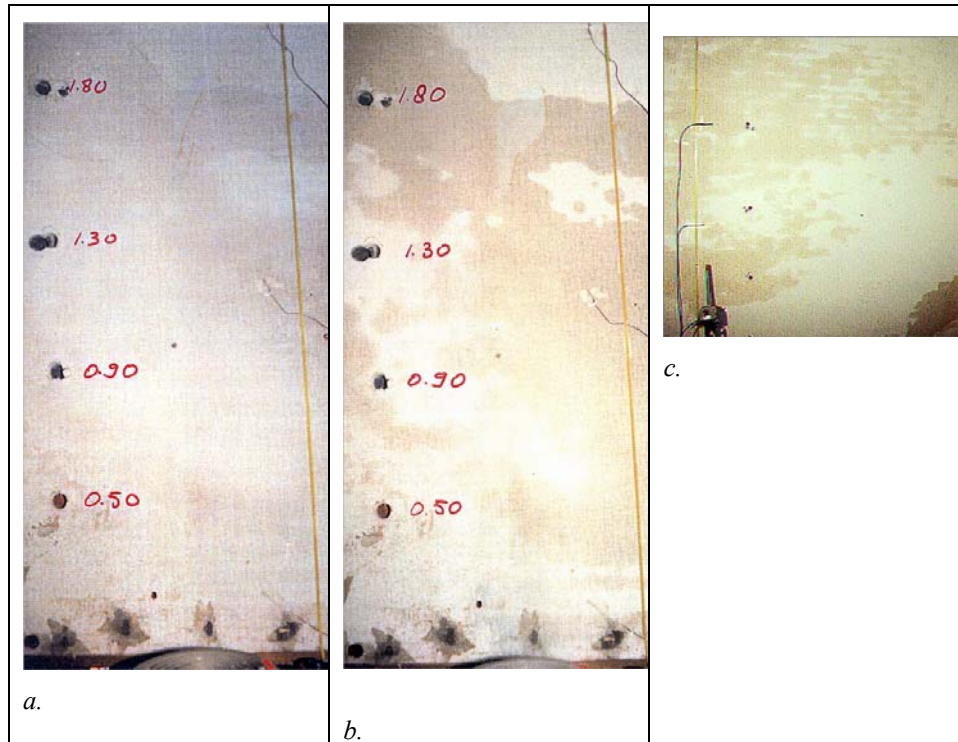
Fig. 3.9.1 Moist zones on a wall surface as a consequence of the increase of the RH of the surrounding air (in this case provoked by an in situ experiment). The numbers indicate the height of the locations of the samples above the floor. In fig. 3.9.1c the effect of the hygroscopicity of the underlying joints becomes visible.

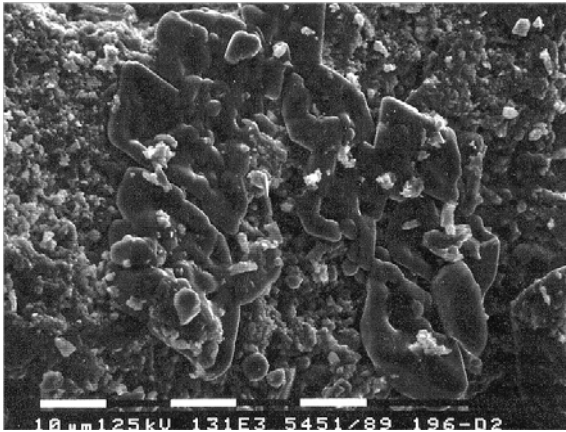
Fig. 3.9.2. SEM picture showing sodium salts (most probably nitrate, which in this case could not be ascertained using SEM/EDX) at the surface of the rendering.

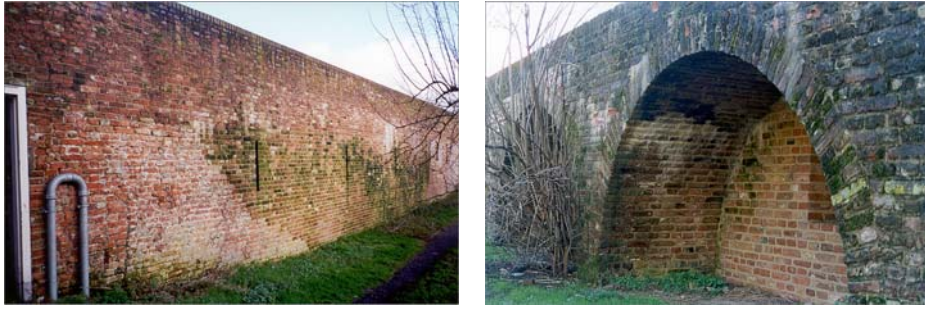
Fig. 3.10.1 Examples of algae growth on an old city wall.

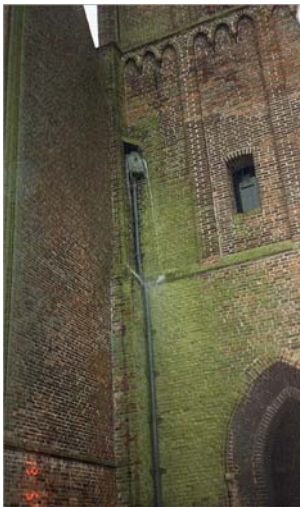
Fig. 3.10.2 Growth of algae caused by to low capacity of gutters and downpipe.

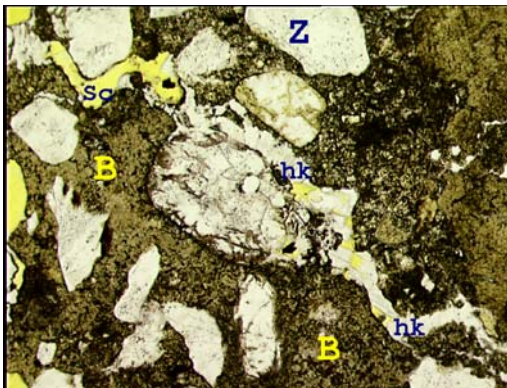
Fig. 3.11.1 PFM micrograph (size 2.7 x 1.4 mm) of a small diagonal crack in a historical lime mortar. Due to re-crystallisation the major part of the crack has been filled again (hk). Z: sand, B: binder

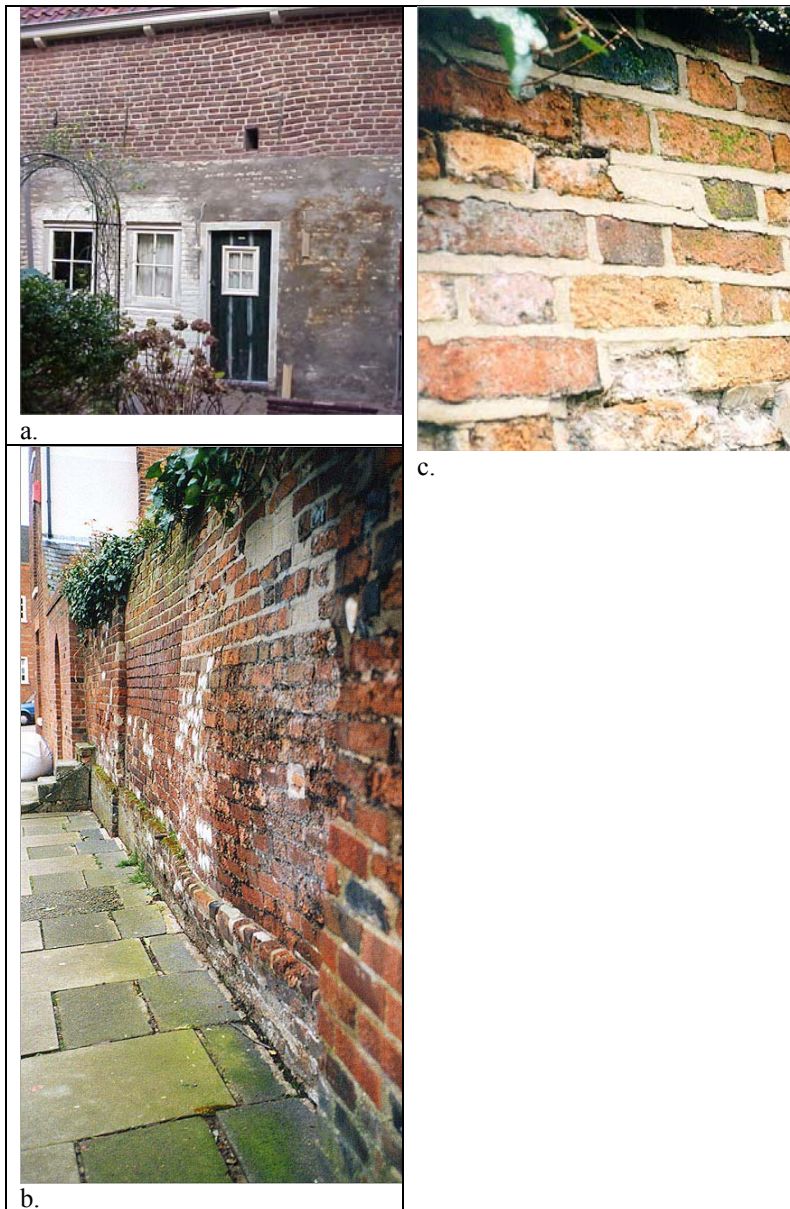
Fig. 3.11.2 Examples of deformation in lime mortars. (a). Setting of masonry in a façade. (b). Bulging of a garden wall. (c.) Detachment of cement re-pointing in the wall shown in b., not following the deformation.

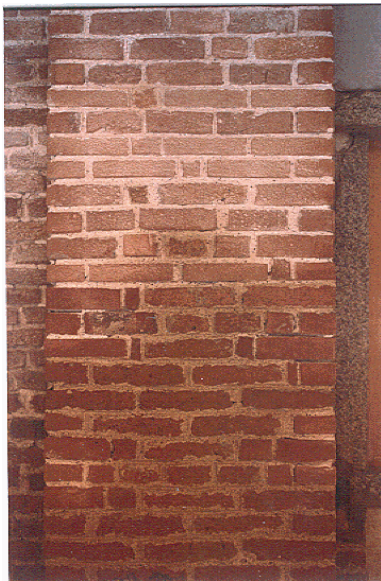
Fig. 3.12.1 Wet zone at lower part of one of the columns.

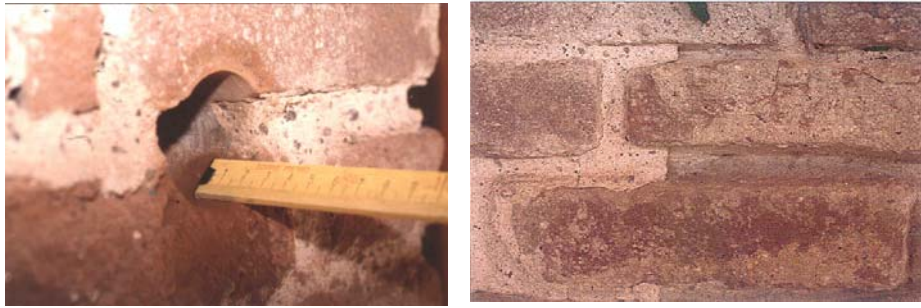
Fig. 3.12.2a/b Missing re-pointing and loss of bond (right part of a). Depth and shape (unfavourable V-shape) of the re-pointing can be seen in b.

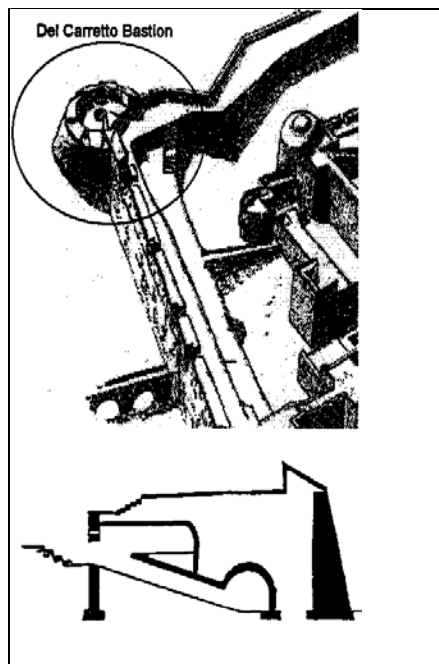
Fig. 3.13.1 Axonometric view and longitudinal section (N-S) of the Del Caretto bastion [Mauri, 1924].

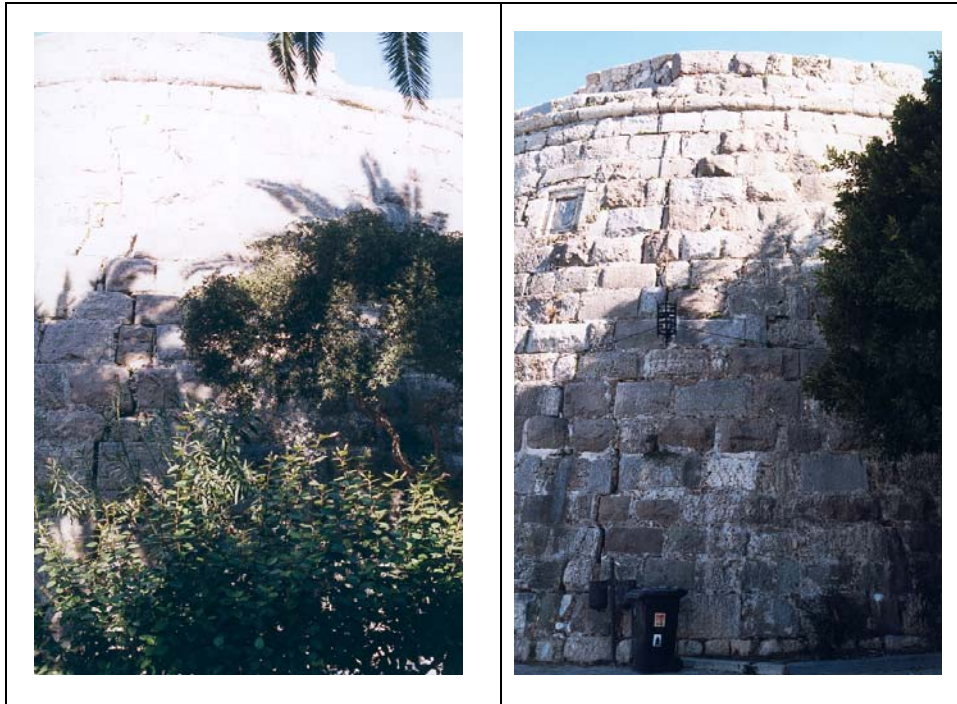
Fig. 3.13.2 Vertical cracks located at two different areas of the bastion

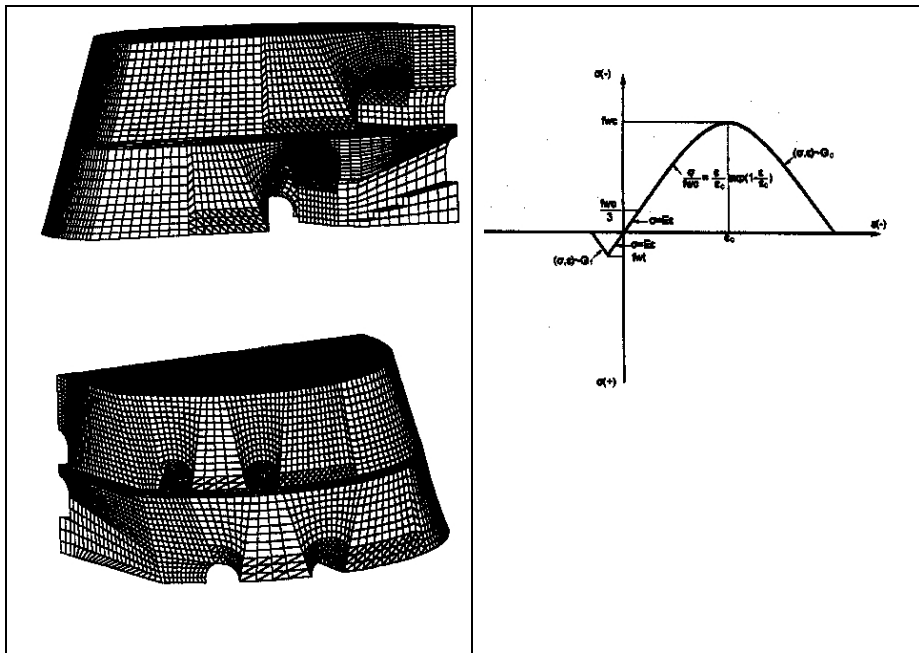
Fig. 3.13.3 Left: Axonometric views of the detailed model (half of the structure is shown)
 – Right: Constitutive law of masonry leaf material

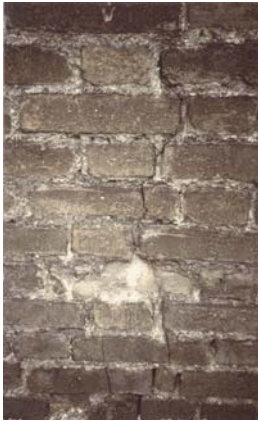
Fig. 3.13.4 Cracks passing through in brick masonry of a bell tower.

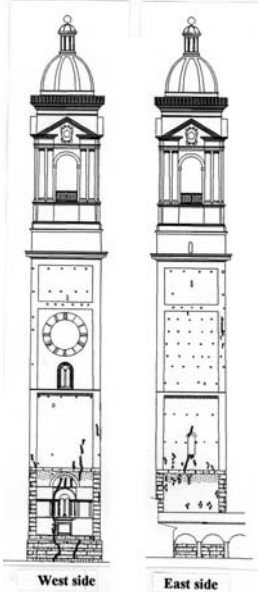
Fig. 3.13.5 Drawing of the crack pattern in a bell tower

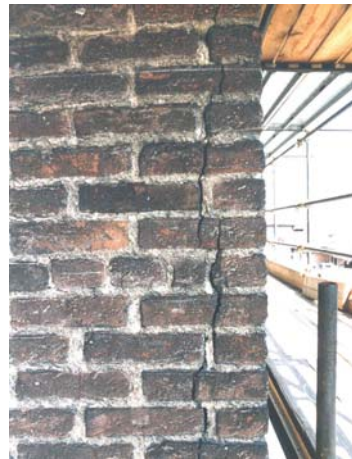
Fig. 3.13.6 Cracks at the corner of the bell tower.

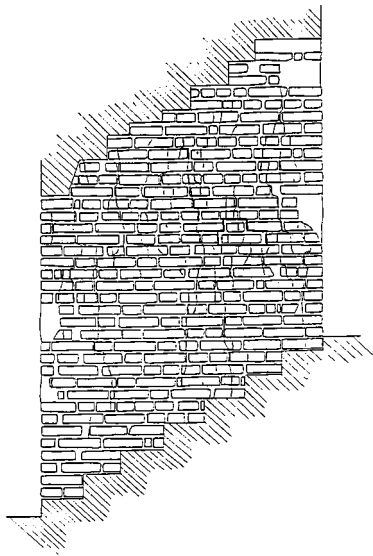
Fig. 3.13.7 Diffused crack pattern at the entrance (height 11 m) of the bell tower.

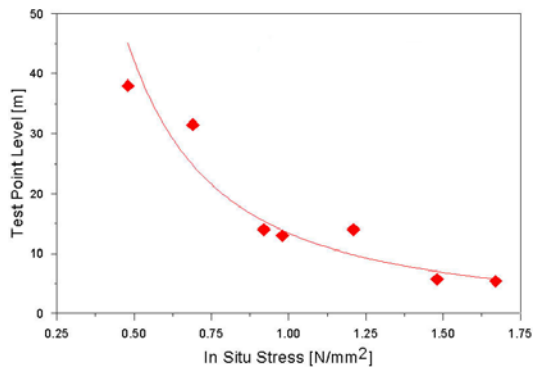
Fig. 3.13.8 The results of a flat jack test on the masonry.

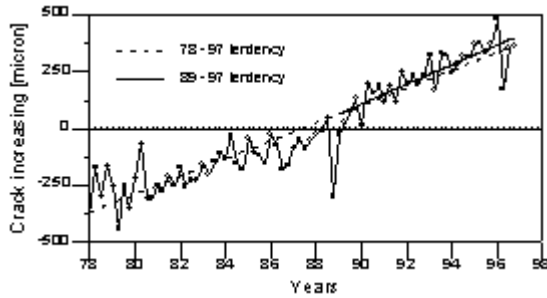
Fig. 3.13.9 Graph of the crack evolution in the bell tower.

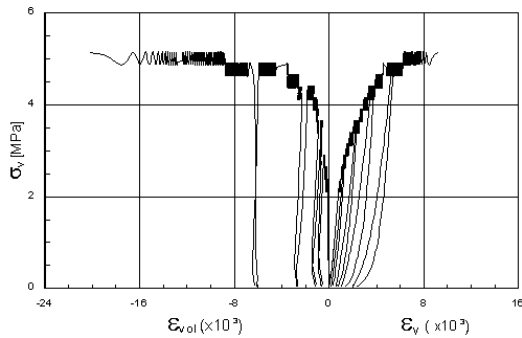
Fig. 3.13.10 Test results showing synergetic action.

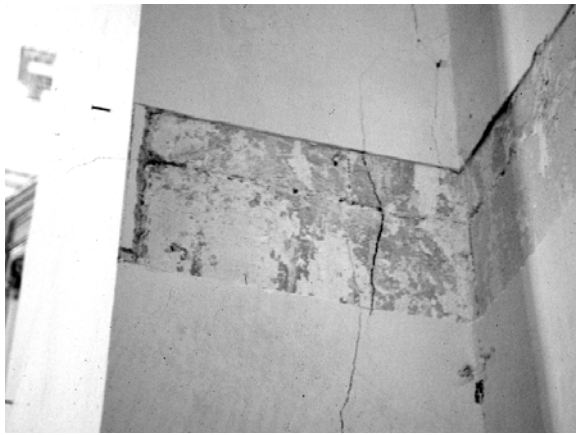
Fig. 3.13.11 Example of creep damage in the pillars of the Church of SS. Annunziata, Ispica, Sicily. It is clear that the cracks on the putty lime plaster are thinner than the ones underneath it. In fact the plaster is also detached as visible in the upper part on the right of this photograph.

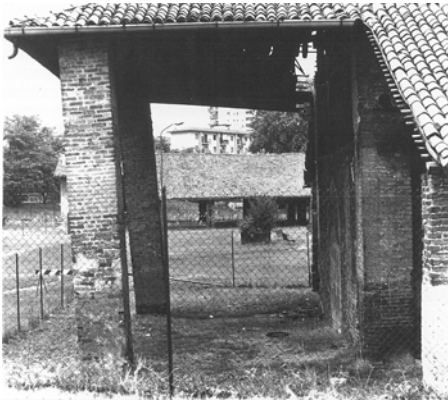
Fig. 3.14.1 Leaning columns.

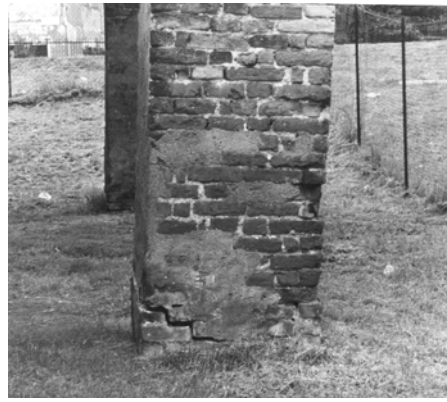
Fig. 3.14.2 Cracks in the mortar joints

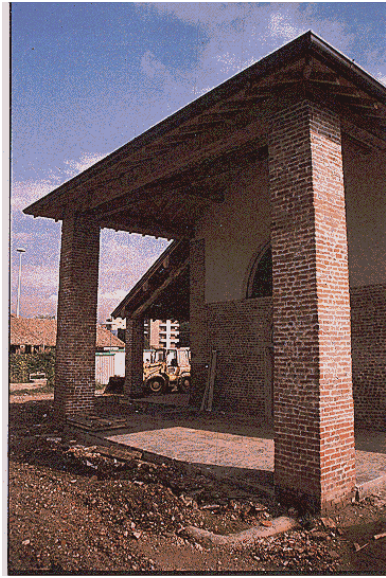
Fig. 3.14.3 The two columns after repair.

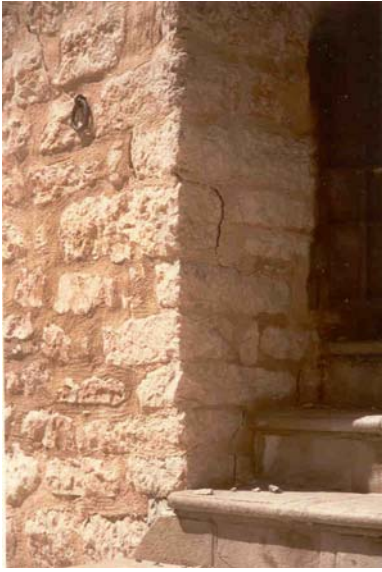
Fig. 3.15.1
Diagonal damage, running through
Horizontal and vertical joints

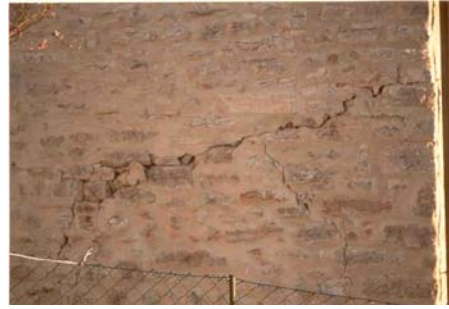
Fig. 3.15.2
Diagonal cracks involving mortar joints
and stones

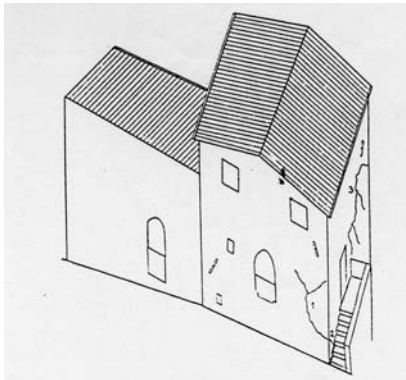
Fig. 3.15.3 Survey of the building to
understand better the crack pattern that
occurred

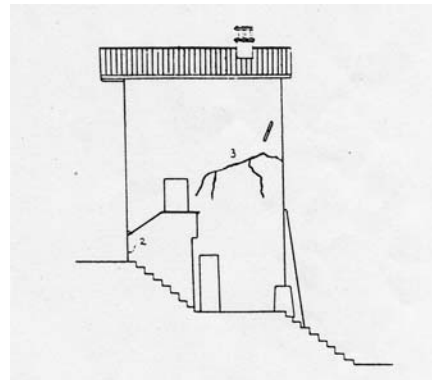
Fig. 3.15.4 Survey showing the diagonal
shear failure of the wall
