APPROACH FOR COMPATIBLE MORTARS FOR RESTORATION PURPOSES: STONE REPAIRS OF THE ROMAN AMPHITHEATRE OF ARLES (FRANCE)

Prepared by **Bromblet Philippe (1)**, **Martinet Gilles (2)** and **Martin François (2)**

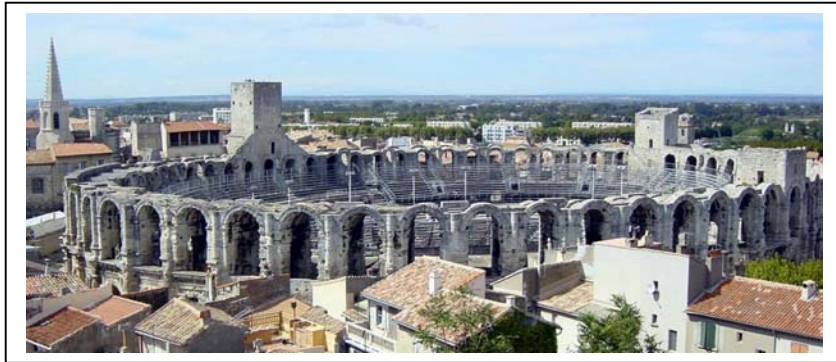
In 2001, the preliminary study for the restoration of the amphitheatre of Arles provided such an opportunity. Built during the first century on the base of an elliptic shape (136x108m), the large roman amphitheatre was in a relative bad condition of conservation (fig. 1) and its restoration project required a multidisciplinary work program.

Figure 1: The roman amphitheatre of Arles, before restoration.

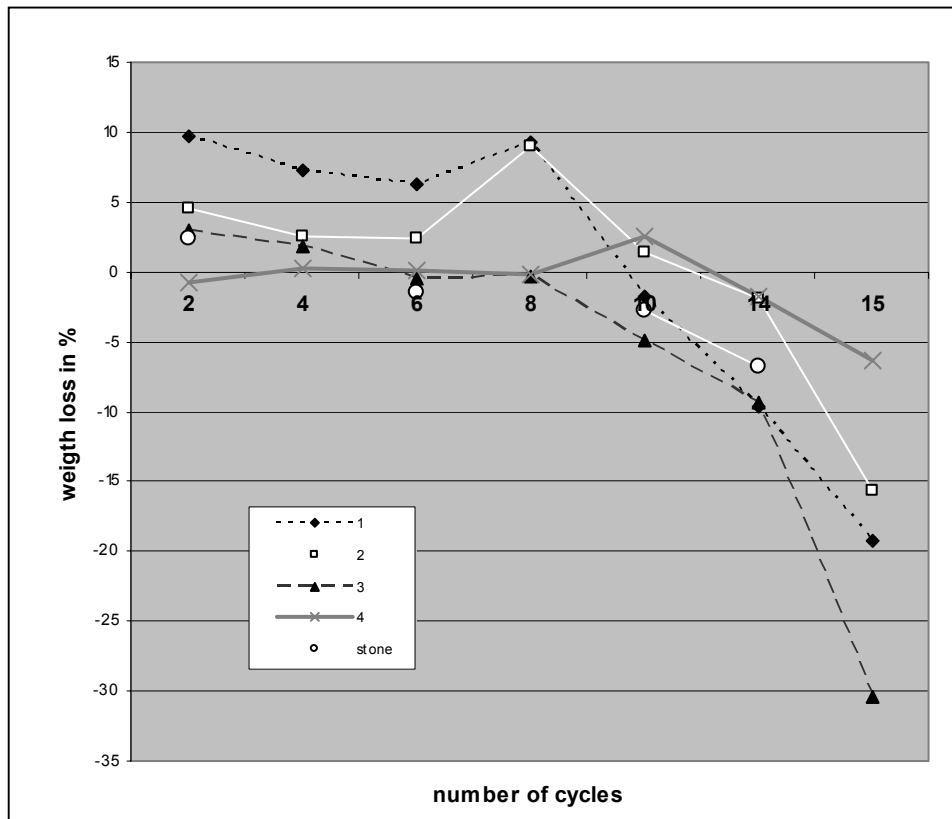
Figure 2: Result of the test of durability (salt resistance) of mortars 1, 2, 3, 4 and stone (quarry of Fontvieille).

During this test, mortar 3 is the material the most affected by salt crystallisations (30% of lost material). Mortars 1, 2 show a very similar behaviour and a higher resistance, but mortar 1 is more resistant during the 8 first cycles while the mortar 2, more porous and stronger, became more resistant after. Mortar 4 is the most resistant and decays at the same rate than the stone of the quarry of Fontvieille.

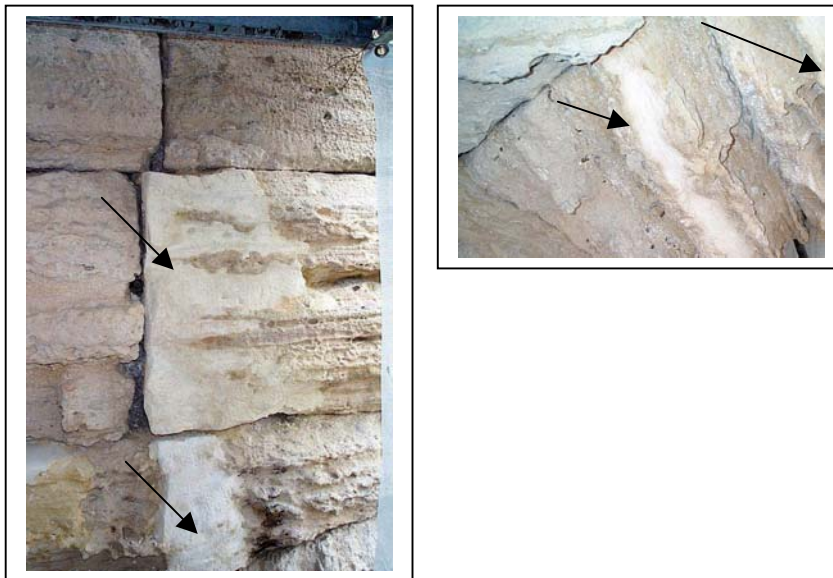
Figure 3: Experimental stone repairs on restricted areas of the vertical wall of a bay and on the intrados of an arch (on the left).

The restorers applied the 4 mortars (fig. 3) and an air lime based mortar as their own reference and gave their opinion in a report [6]. Visually, the best reparations were made with mortars 1, 2 and 3: they looked like the stones. But if mortar 1 was right in thin layer, it did not fit at all over 2 to 3cm, even in 2 layers : the reparations cracked and fell apart from the stone substrate because of their important shrinkage, their too long setting time and their difficult workability. Mortar 3 was more easy to use but was too dark and grey to be coloured yellowish like stone and then required a patina. Mortars 2 and 4 were much more convenient to use in different thicknesses and the various colours which were encountered. They were creamy, unctuous. They didn't crack whatever the thickness and the extension of the repairs.

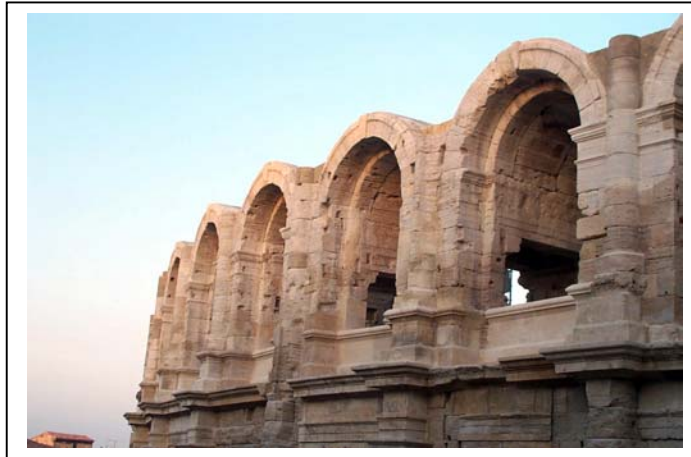
Figure 4: The first seven restored bays of the amphitheatre of Arles.

A first experimental restoration work then was undertaken in 2003 on 7 bays (fig 4) over the total 60 bays of the amphitheatre. This initial work allows to assess the behaviour of the selected mortar (mortar 4) in the field before the beginning of the first phase of the restoration which will deal with 20 other bays of the monument [7].
