RILEM TC 167-COM: 'Characterisation of old mortars with respect to their repair'

Characterisation and damage analysis of old mortars

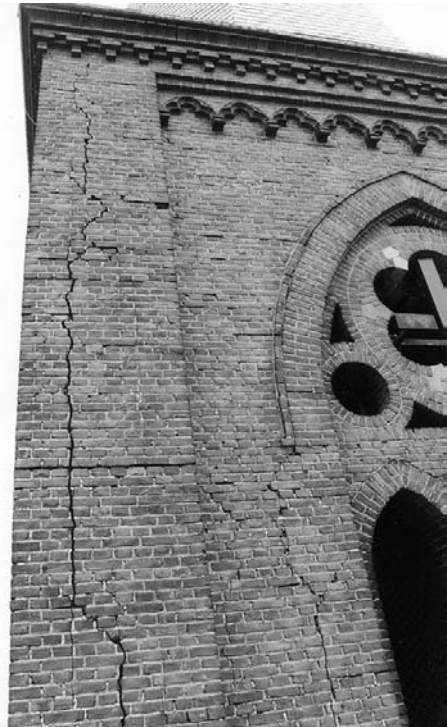
Fig. 1 - Wide (vertical and also horizontal) cracks, on the first sight looking like structural cracks, were found to be caused by swelling compounds in the inner part of the masonry.

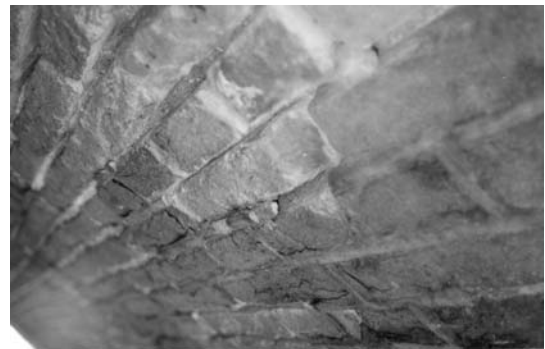
Fig. 2 - Damage in the passage(way) of a historical arch bridge: spalling of brick and pointing is pushed out.

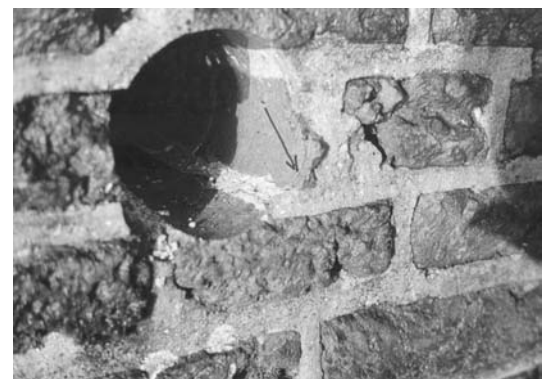
Fig. 3 - Start of damage visible in the hole left by the drilled core (see arrow for location): a layer of the brick begins to detach, the bedding mortar shows loss of cohesion.

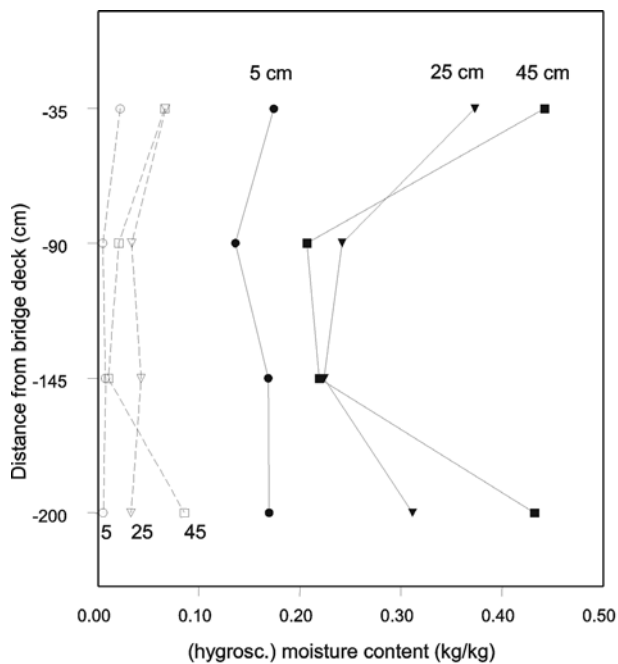
Fig. 4 - The moisture content (and distribution) in one of the bridge pillars as a function of the distance from the bridge deck and as a function of drilling depth (5, 25 and 45 cm). The continuous lines indicate the moisture profile. The dotted lines represent the hygroscopic moisture content at 93% RH and give an indication of the salt profile.

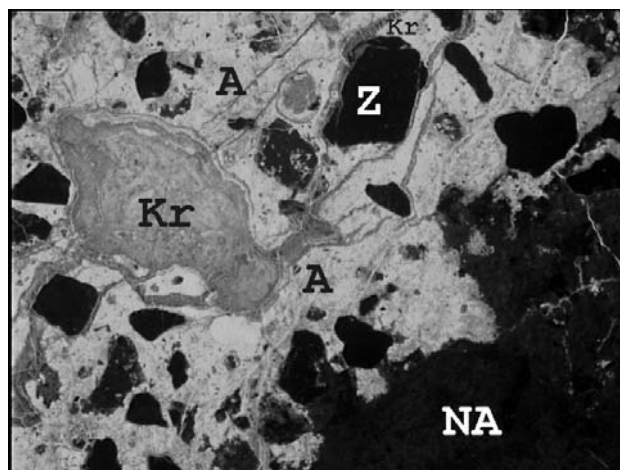
Fig. 5 - PFM picture (fluorescence) of decayed mortar. The dark not decayed zone has lower porosity. In the left part (light colour) the porosity is clearly higher; this is due to the dissolution of the binder; 'A' is used to indicate the decayed zone, 'NA' for the not decayed zone. The decay is shown by this phenomenon as well as by concentrations of structures in crystal form indicated by 'Kr'. Dimensions of the section shown are 2.7 x 1.8 mm (magnification: 50x). Location -/- 200 cm below bridge deck, depth 5 to 10 cm from the wall surface (see Fig. 4).
