Proceedings of the International Conference on Sustainable Materials, Systems and Structures (SMSS2019)

Durability, Monitoring and Repair of Structures

**International Conference on Sustainable
Materials, Systems and Structures
(SMSS 2019)**
Durability, Monitoring and Repair of Structures

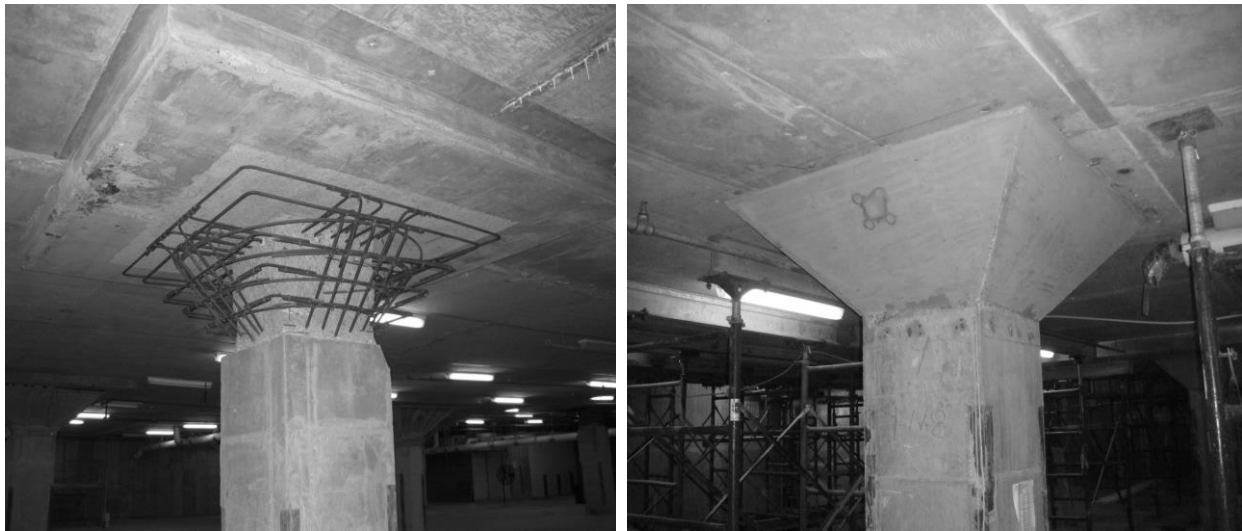
Figure 4: Column capital prior to and after concrete placement

An economical repair approach incorporating supplemental concrete column capitals and drop panels at each column and strengthening of selected slab spans using FRP was selected. The conventionally-reinforced square capitals and supplemental drop panels were doweled into the top of the existing columns and were poured using a concrete mix design which allowed the repair material to be pumped into the forms from below the existing slab. Photographs of a supplemental column capital prior to and after concrete placement is shown in Figure 4.

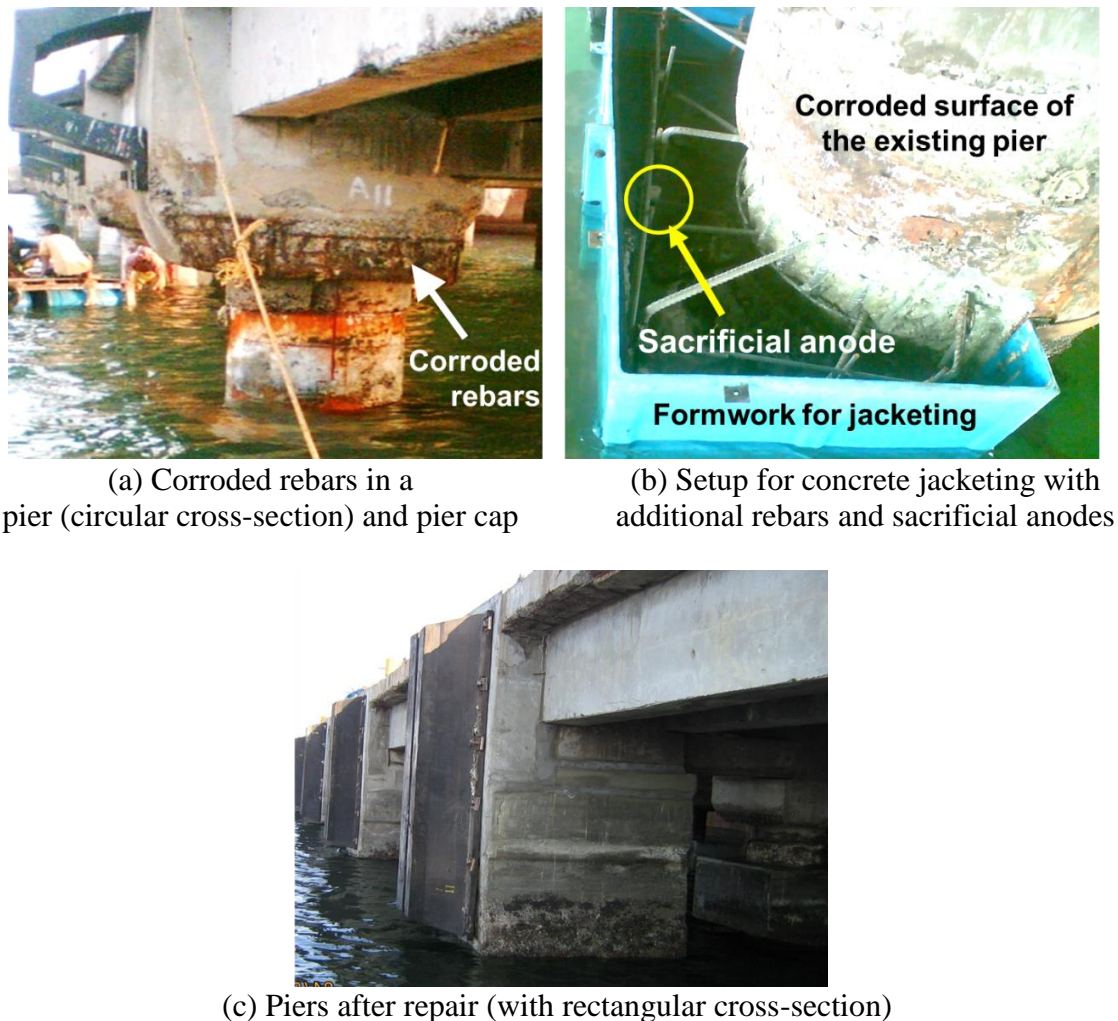
Figure 2 Finger jetty in the coastal region
