## Strategies for the assessment of historic masonry structures

L. Binda, C. Maierhofer

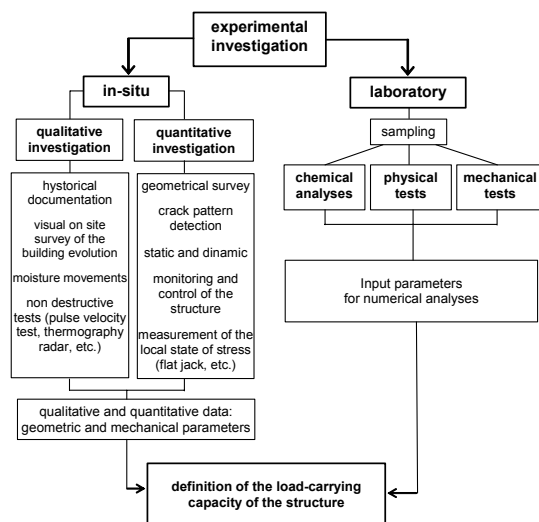
**Figure 2** Finalization of the experimental survey to the structural analysis

Figure 2 shows, as an example, which information is available from in-situ and laboratory surveys and how it can constitute the input data for the structural analysis. When the design of the survey is available, the conclusions from the experimental and numerical investigation will diagnose the real state of the structure.

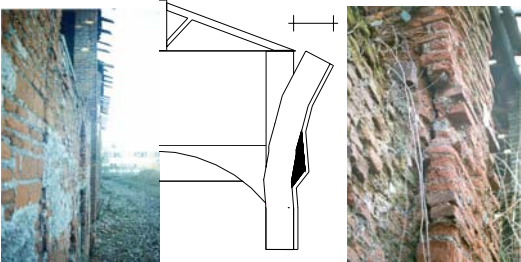
<b>DAMAGE:</b> Vertical cracks on the middle part of a brick masonry built in column causing detachment of a layer.
<b>Structural element*:</b> Solid masonry built in column.
<b>Description:</b> Vertical cracks are evident on separating the external part of the column.
<b>Origin(s):</b> Due to excessive horizontal and vertical loads on top of the column which at first cause rotation of the upper part of the column at the upper floor. The lack of protection caused the rain to go through the column. Salt crystallisation and frost-defrost action caused the loss of material and the detachment (expulsion) of a thick layer of the external part of the built in column.

<b>Measurement Parameters:</b> depth, width and length of the crack over time; geometrical dimension of the pier, masonry composition, deformation, out of plan and inclination of the pier; state of stress; strength., acting loads, radar reflections

<b>Applicable Non Destructive Techniques:</b> geometrical and photographic survey, sonic tests, radar

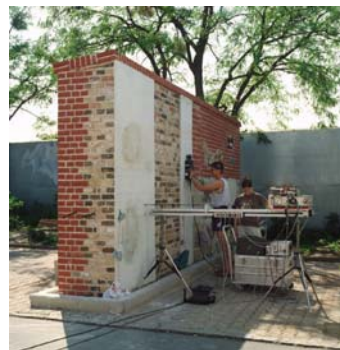
**Figure 3a** Historic Masonry Specimen “Obelix” at BAM

A large masonry wall simulating various situations found in historic walls has been constructed at BAM in close cooperation with Luther Memorial Foundation in Saxony-Anhalt (Wittenberg, Germany), Institute for Diagnostic and Conservation at Monuments in Saxony und Saxony-Anhalt e. V. (Halle, Germany) and Institute for Applied Science in Civil Engineering (IaFB), (Berlin, Germany). This wall called “Obelix” features a diversity of typical materials, structures, and non homogeneities (e. g., brick and stone, multiple leave structure, voids, wooden pile, metallic beam, metallic anchors) and thus represents several aspects of real historic masonry (see Figure 3). This specimen with the dimensions 7 m x 3 m x 1.5 m has been planned and constructed in consideration of traditional manufacturing techniques, partly by using historic materials from demolished buildings. It represents a large variety of problems and characteristics of real historic masonry (e.g., mixed masonry, multiple-leafed walls, hidden inclusions, cracks, voids, etc.). Each of the characteristics or properties of this Historic Masonry Specimen, which has been erected by a very experienced building company specialized in the restoration of cultural heritage buildings, is known in detail. This specimen is, in a way, the link between usual masonry specimens and real historic masonry buildings and will make the validation and calibration of the investigation techniques possible. It enables

investigations under more or less defined conditions. The detailed documentation compiled during construction permits a reliable interpretation of the recorded experimental data.

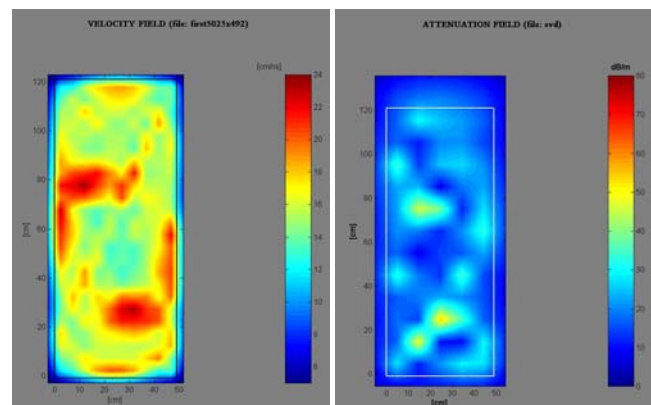
The data were processed by POLIMI with the TOMOPOLI [13] software, also developed in the project. The result from travel time tomography, i.e., the velocity map is shown in Figure 9. Two clearly visible anomalies are detected, corresponding with the positions of the voids. The velocity of the wave propagation is much higher ( $> 24$  cm/ns), around the position of the voids as it is in the brick masonry (13-15 cm/ns). The resolution of the tomographic reconstruction is encouraging.

**Figure 9** Left, velocity map resulting from the travel time tomography. Right, attenuation map resulting from the application of the frequency downshift method
